Preliminary Laser >> Mast Report #2, 1 July 2012

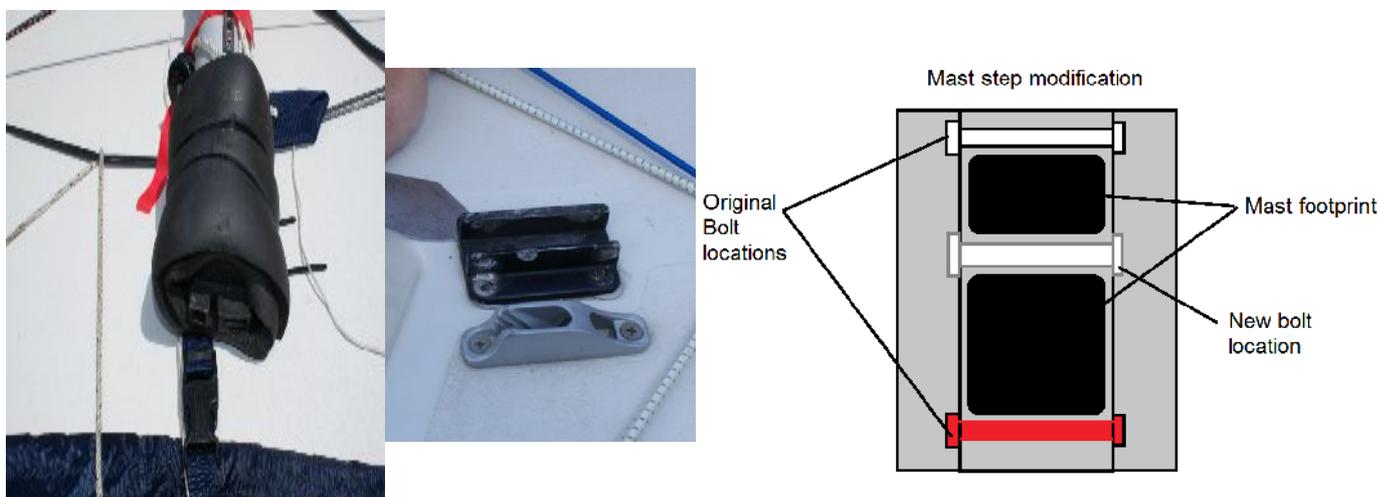
- Mast foot: the new mast has a different foot to the original, meaning that it does not fit into the step (Mast foot is now 60mm long, just too big to fit within the original bolts. Dan Slater at Sailboats mentioned that customers of the new mast will be supplied with a new mast step.) The potential problem with this is that the footprint of the new step will not exactly overlap the original, so the compression put into the boat by rig tension could be offset from the below deck mast strut, leading to a structural collapse beneath the deck (bearing in mind the age of many boats). To get round this, I removed the mast step, measured the heel on the new mast and drilled a second hole, which was through bolted (diagram below) the original aftmost bolt (shown in red) being removed. This allowed the small groove on the mast step to sit over the new central bolt, stopping all movement. This solution is reasonably simple and worked well – it would be easy to put together a simple guide to go with new masts.

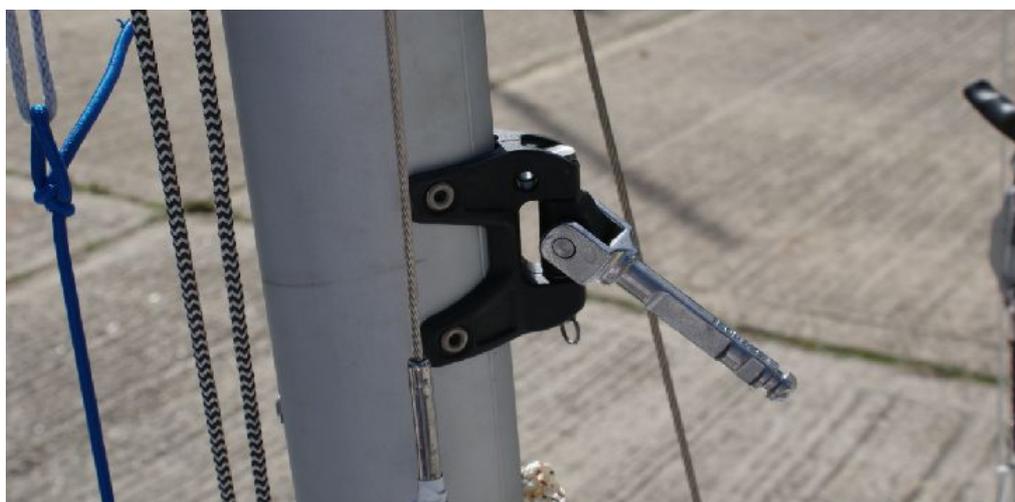
- D-ring: again too high; the ideal / common location is around 79cm from the end of the mast section. (The prototype will be changed to this height.) All other spinnaker fittings are good quality and in the correct locations, although wind strength and space dictated that spinnaker flying wasn't appropriate, sadly.
- Gooseneck: correct height and looks robust, but is too small a diameter! This problem was spotted when the boat was rigged in Northampton, but but it was decided that it was the worn out boom plug that was at fault. However, even with a newer plug, it still had some play in it, so really a better fitting alternative needs to be found.

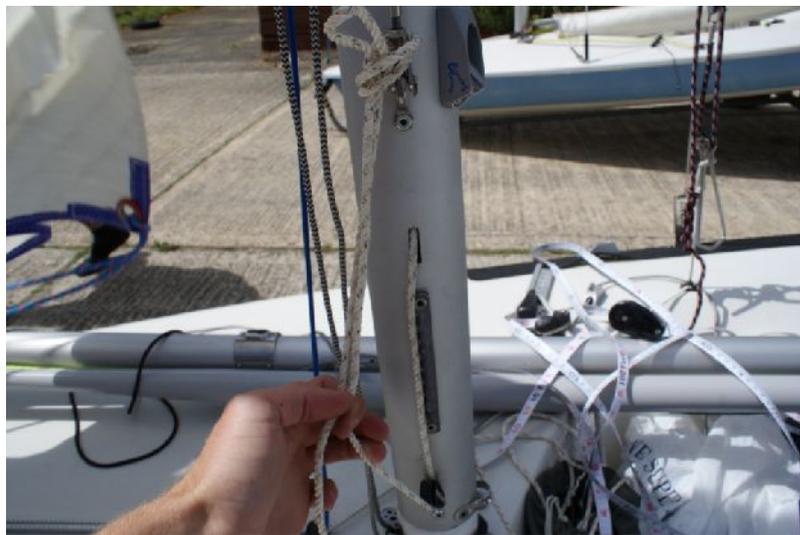
- Main halyard: this is similar to the original system, a wire halyard with a rope tail. However instead of going through a sheave at the bottom of the mast, it comes out through a slot which it is very tricky to feed the wire join through. It is then secured onto a rack as per the original mast. This would be a better arrangement were a complete low-stretch rope halyard to be used with a simple clam cleat, like other more modern classes (Laser 2000 etc.).

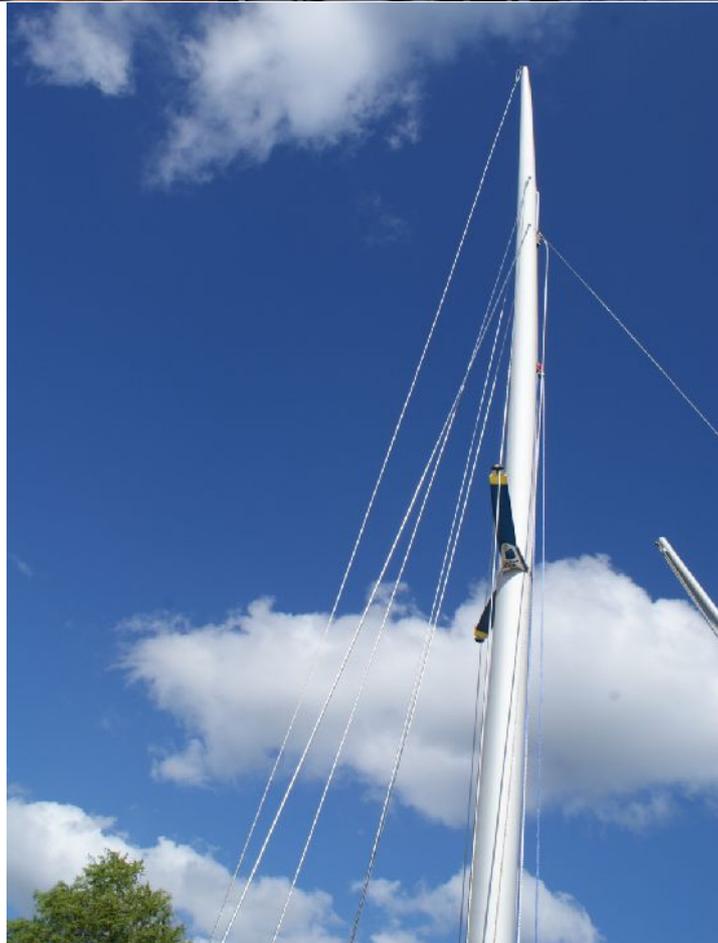
- Spreaders: these short aero-foil section diamonds were slightly swept backwards, but actually worked very well. A quick chance to sight up the mast during the sail showed that the bend was 'perfect'. Rig tension measured with a loos gauge (not guaranteed 100% accurate) was 30 on the shrouds and 24 on the diamonds. In terms of balance: the shrouds were set to the middle of the range using an extension piece in the jib halyard. It was very raked when I sailed (6.22m tip to gudgeon) but still felt reasonably balanced. A further few sails are required to take make a good judgement.
